BATCH HOME INSPECTIONS LLC

## RESIDENTIAL REPORT

1234 Main Street  
Denmark, TN 38391

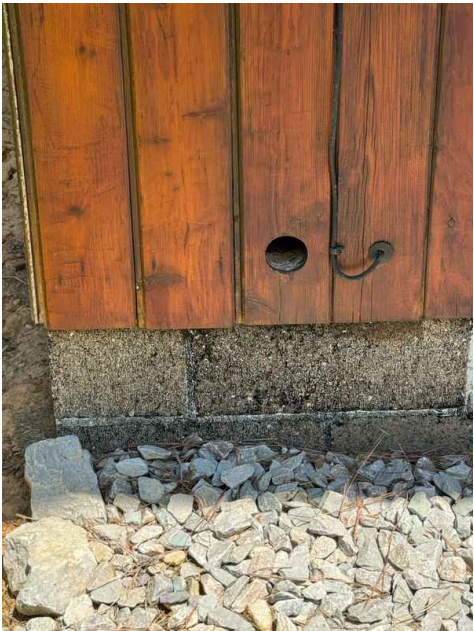
2.2.2 Siding, Flashing & Trim

**VENEER OPEN PENETRATION**

A hole/penetration in the red cedar veneer from the past. It is a clear opening to the crawlspace for weather, insects and animals to enter. Recommend sealing the penetration.

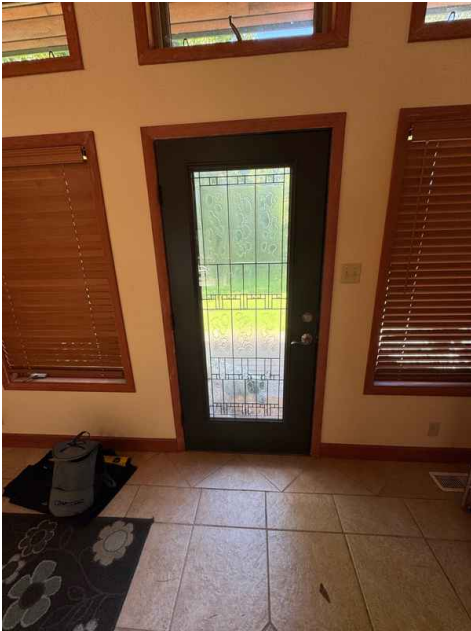
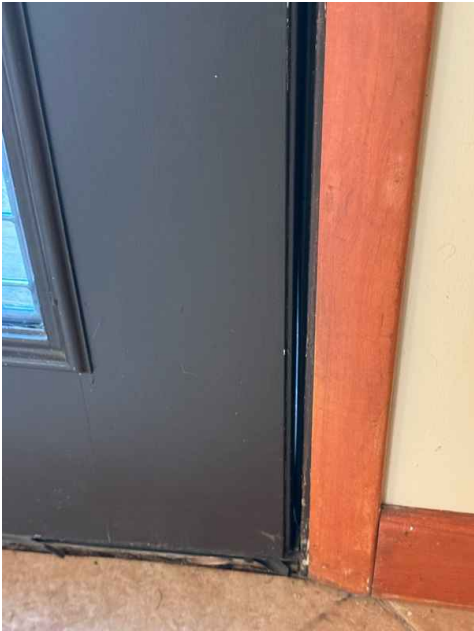
2.3.1 Exterior Doors

**FRONT DOOR EXTERIOR**

Front door needs adjusting. The seal around the door needs to be adjustment or replaced. The is a slight gap between the door and frame, which will emit outside air and humidity to enter the space.

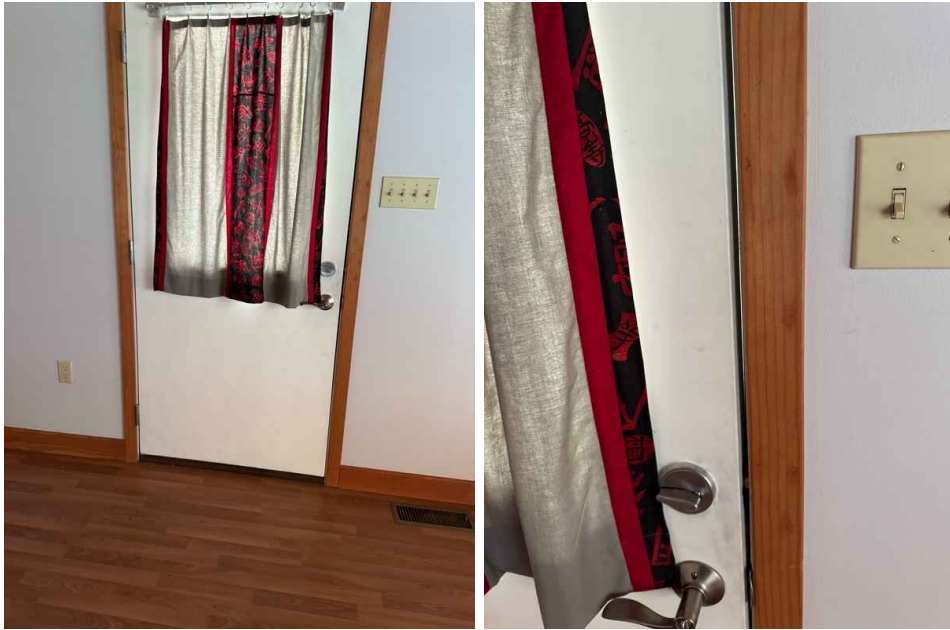
2.3.2 Exterior Doors

**SECOND LEVEL EXTERIOR ENTRY DOOR**

The entering door on the second level room from the balcony has a steel door with a storm door installed. The storm door does not latch. The steel door does not lock; the deadbolt lock will not secure and needs adjusting. There is also a gap between the door and frame allowing air and humidity seepage.

Contact a qualified handyman.

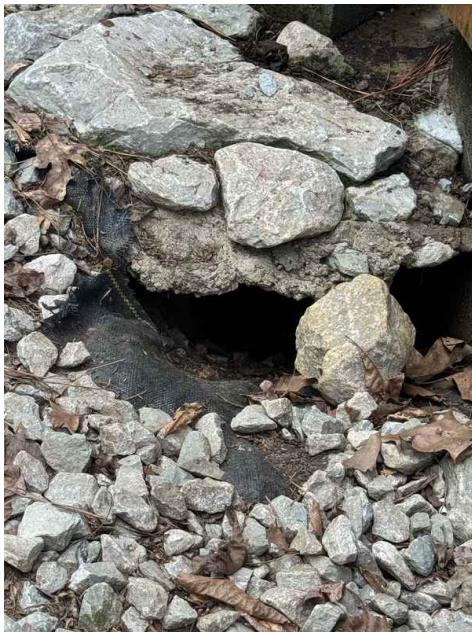
There is evidence of water erosion at the southeast corner of the house where water has been penetrating next to the basement and foundation.

Erosion Hole-Southeast 2

Recommend a qualified engineer to investigate possible water intrusion for all these area.

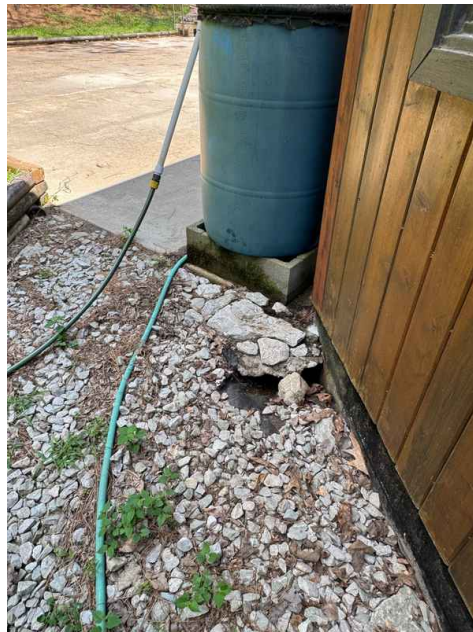
Erosion Hole-Southeast Corner

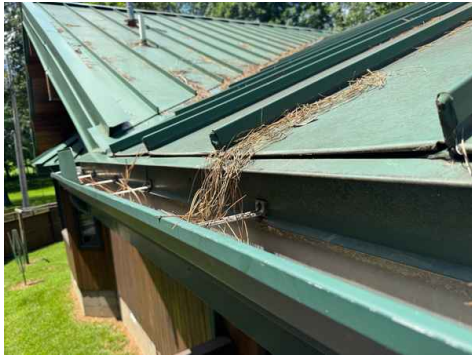
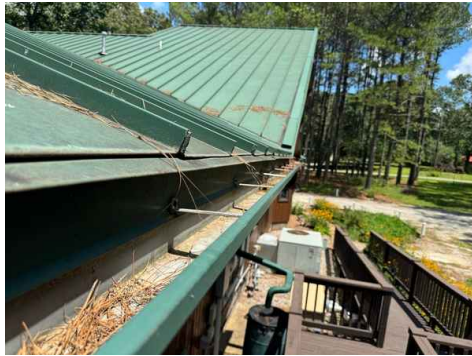
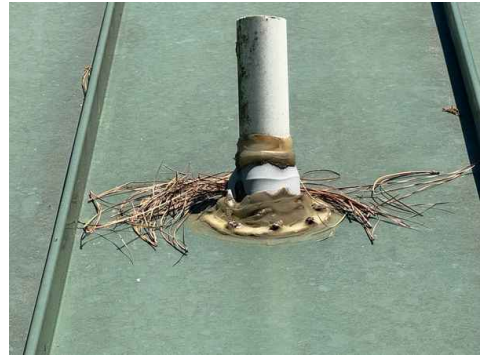
Downspout on the northwest corner of house discharges to a relatively flat area. Recommend extending to the nearest ground slope or ground drainage path to not allow water to gather near the foundation.

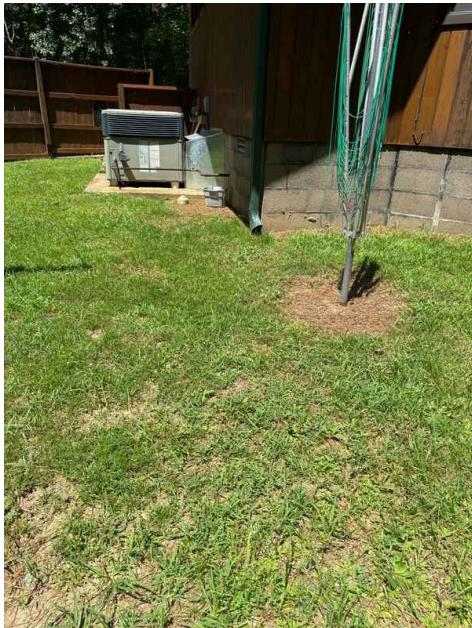
### 3.2.1 Roof Drainage Systems

#### **DOWN SPOUT**

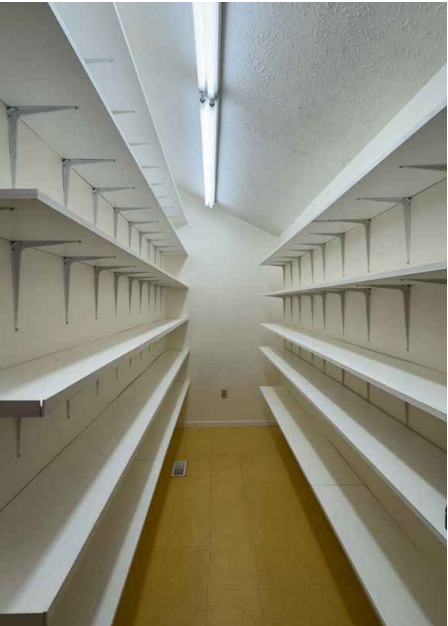
Walk-In Closet/Pantry

The walk-in closet/pantry is located Great Room Kitchen. The ceiling is in line with the "valley" of the metal roof seam. There is evidence of moisture penetration in the past, but the area check out to be dry indicating no active water intrusion recently.

Recommend monitoring during periods of rain.

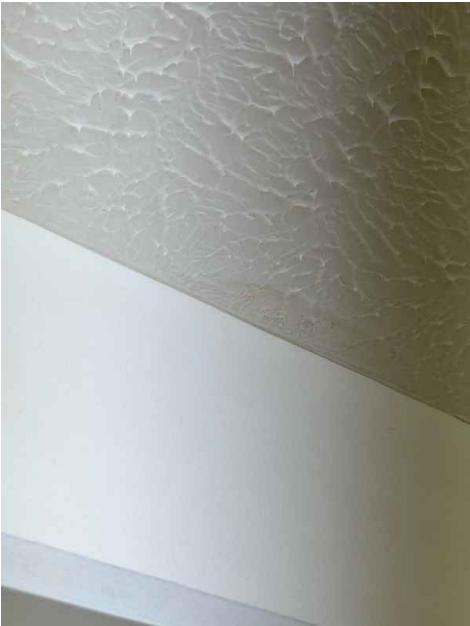
Dry Water Stain

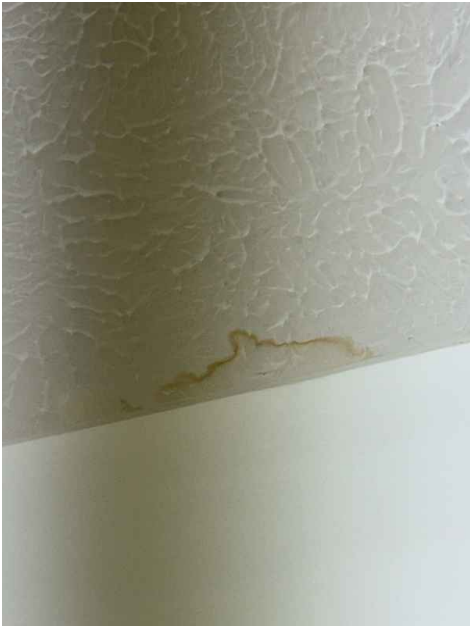
Dry Water Stain 2

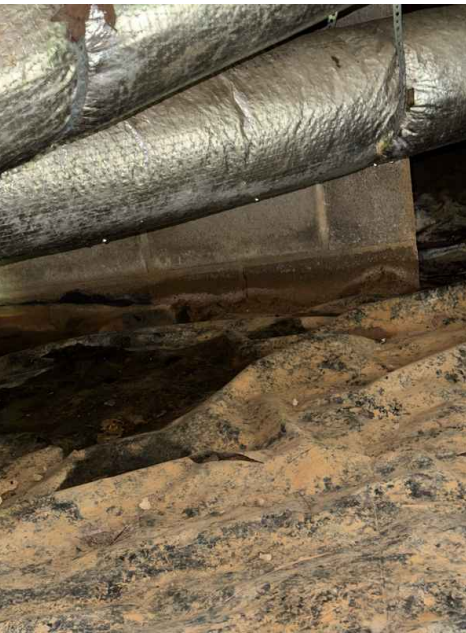
4.2.1 Basements & Crawlspaces

The crawlspace visual inspection displays standing water along the south, east and west concrete supporting foundation walls, as well as standing water around the concrete piers on the southside of the crawlspace.

There is substantial water under the main trunk air conditioner (supply air duct). There is visual evidence that the air conditioner ductwork (supply air duct) under the house is not insulated, causing condensation to drip under the house.

Visual inspection of the crawlspace on the southside where the basement is located is damp. There is evidence of some type of water remediation on the basement walls, being newly placed form boards on basement walls but moisture is still present in this area.

Recommend a qualified contractor evaluate and find potential moisture source.

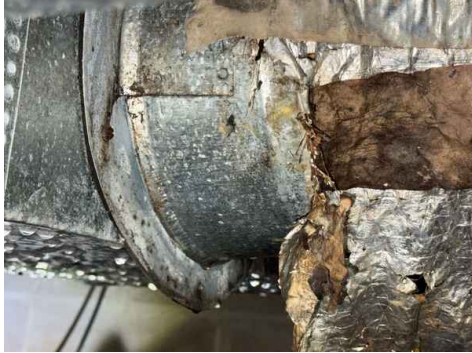
There is substantial water under the main trunk air conditioner (supply air duct). There is visual evidence that the air conditioner ductwork (supply air duct) under the house is not insulated, causing condensation to drip under the house.

When a cool and uninsulated ductwork is exposed to warm moist air, water is emitted on the surface of the ductwork and drips to the ground under the house.

Missing Insulation

Contact a qualified HVAC professional.

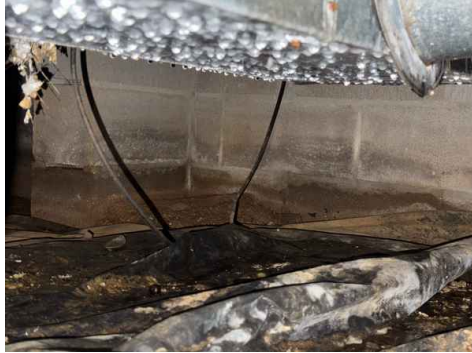
Cooling Trunk Condensation

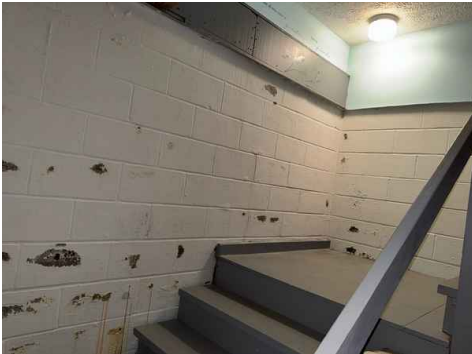
Moisture Detection Lower Wall (High Reading)

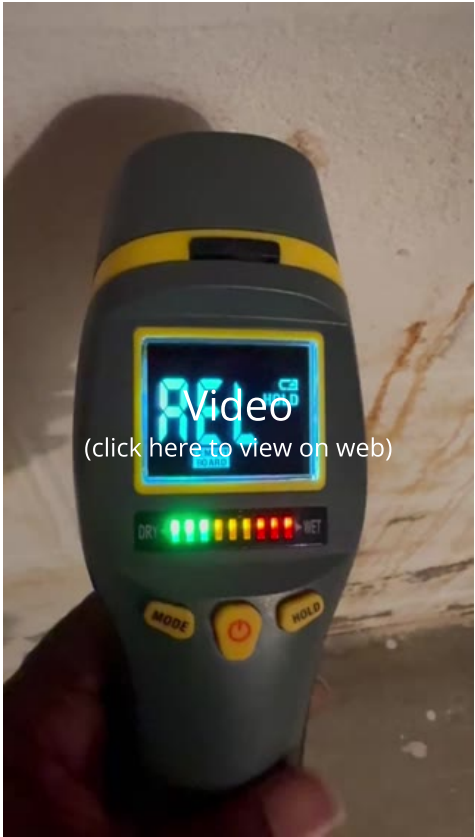
Moisture levels were taken at the bottom of the wall and top of the basement wall. High moisture levels were identified at the bottom of the basement walls showing a substantial amount of moisture still present in the walls.

The source of the water intrusion needs to be professionally identified and corrected. Environmentally dried out using heat and conditioned air, and moisture levels monitored daily by a qualified contractor.

I recommend an evaluation by an environmental engineer and a professional remediation contractor.

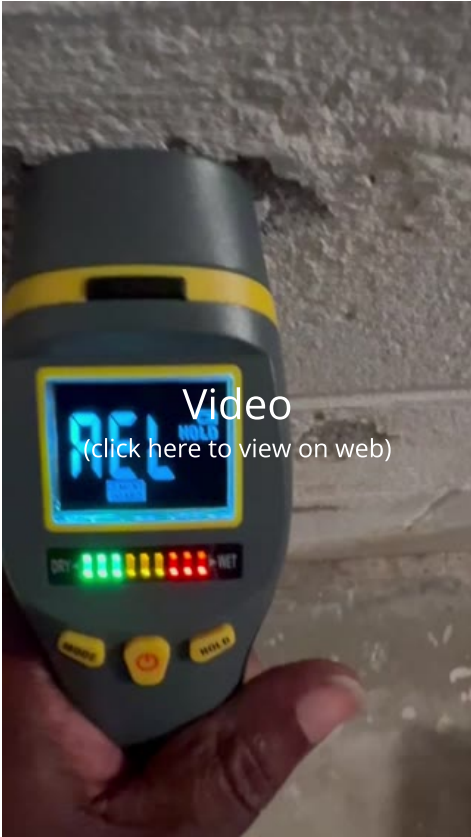
Moisture Detection Lower Wall (High Reading) 2

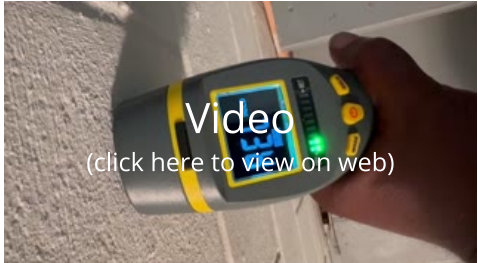
Moisture Detection Upper Wall (Lower Moisture)

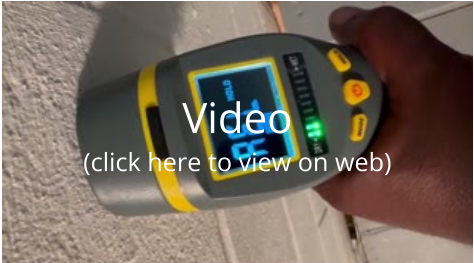
Moisture Detection Upper Wall (Lower Moisture) 2

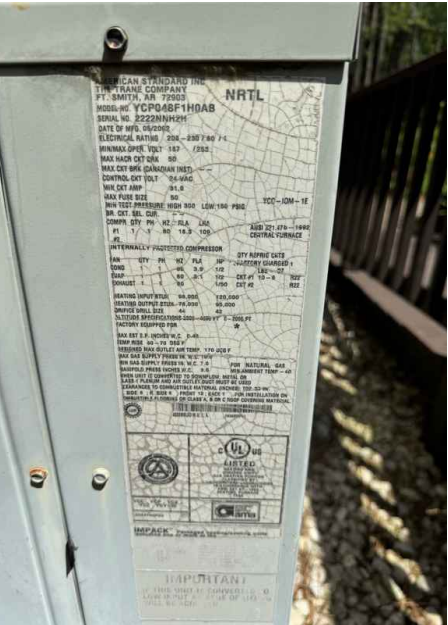
The Westside air conditioner/heating unit is a 4-ton cooling and gas fueled heating system. Manufacture date 2002, with R22 refrigerant. R22 refrigerant is no longer being produced and is an expense to replace or repair.

The age of this unit is over 20 years, and the life expectancy of air conditioners is 15-20 years.

This unit condition displays wear. Indoor temperature was 75 degrees, the cool air discharge at the indoor vents was 64 degrees, and return air of 73 degrees. Acceptable.

This unit is past its efficient life expectancy.

Westside HVAC Package Unit

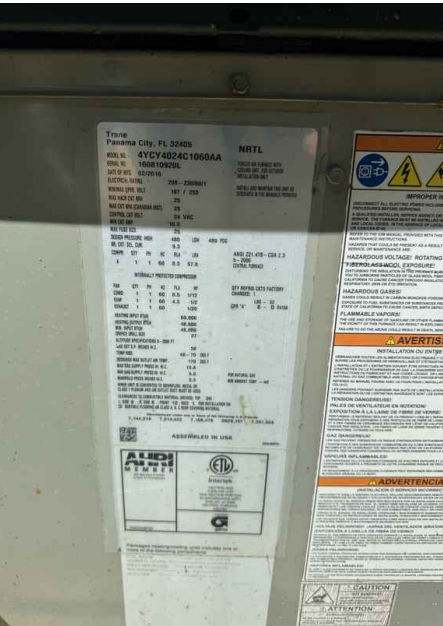
Northside Package HVAC

This unit is in acceptable condition. Indoor temperature was 75 degrees, the cool air discharge at the indoor vents was 60 degrees, and return air of 75 degrees. Acceptable.

The acceptable difference between return and supply air is between 16-22 Degrees.

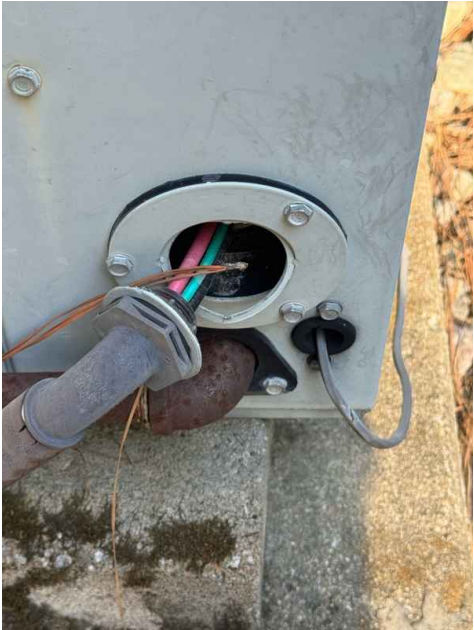
DAMAGED WATER-TIGHT ELECTRICAL CONNECTION

Damaged water-tight electrical raceway and connection. This can lead to damage electrical wiring, water intrusion, shock hazard.

Contact a qualified HVAC professional.

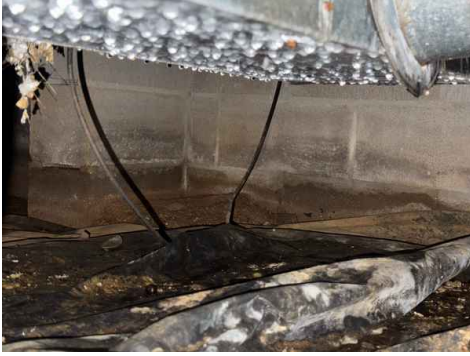
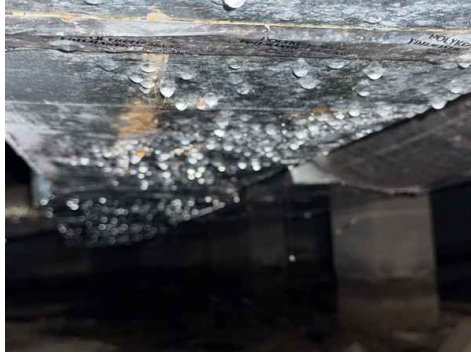
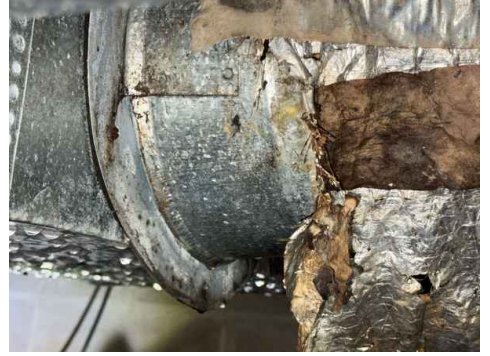
6.3.1 Distribution System

DUCTS UNINSULATED

Ducts are not insulated, resulting in energy loss. Recommend licensed HVAC contractor insulate ducts. This was also documented in the deficiencies of the crawlspace

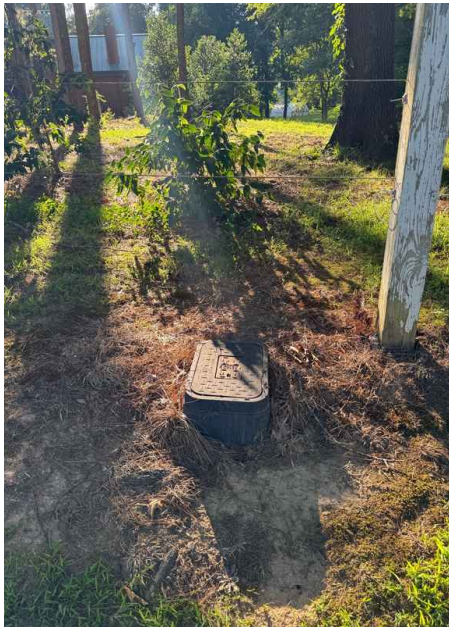
Water Meter Public Roadside

This property uses city water with the main meter located along the public road. This meter serves the house with the shut-off located on the eastside of the house, and another shut-off to the detached workshop located on the hill to the north (shut-off is located under "hinged step" outside the workshop).

Both meters and shut-offs were inspected and there was no sign of leakage.

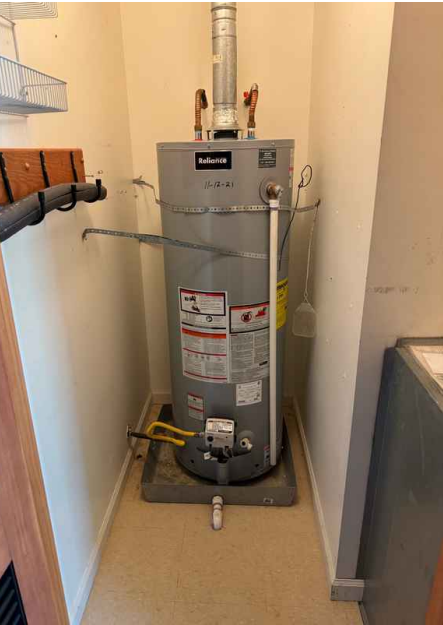
Water Heater Near Great Room

In this house, there are two water heaters. One is located in the utlity closet of the handicapp accessible space 30 Gallon Capacity, and the other is located in the utility closet near the great room 50 Galloan Capacity. Both are natural gas powered.

Both water temperatures were tested at the respective sinks and both had 114 degree water. No evidence of lwater leaks, and no evidence of gas smells or detected with gas anaylizer. Acceptable.

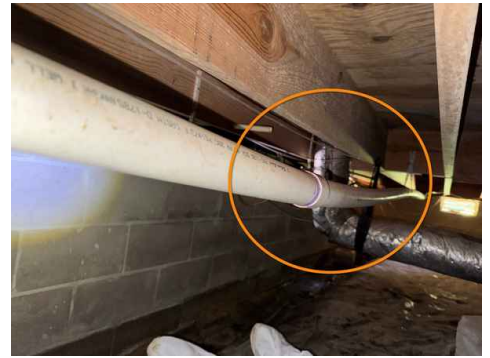
7.2.1 Drain, Waste, & Vent Systems

IMPROPER SLOPE OF DRAIN LINE

Recommend a professional plumber to correct the slope for the entire drain run.

Contact a qualified plumbing contractor.

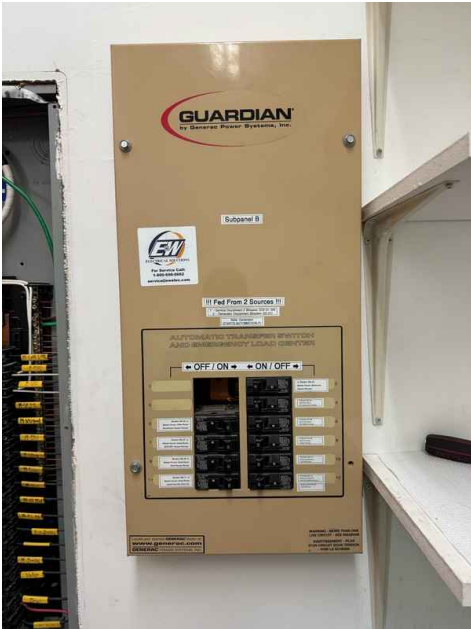
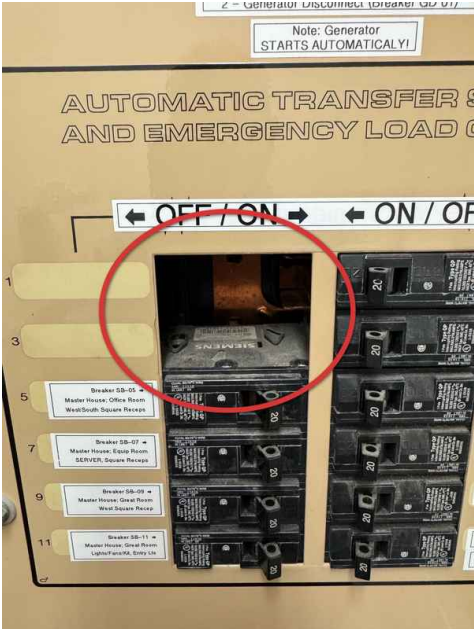
ATS Panel

The generator panel located indoors is missing a blanking plate. This is a shock hazard with the electrical buss exposed.

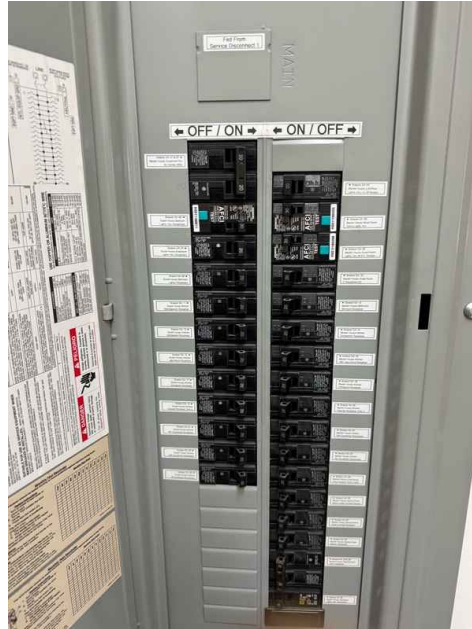
Exposed Main Panel

Main Panel Dead Front

Recommend a qualified electrician.

Contact a qualified electrical contractor.

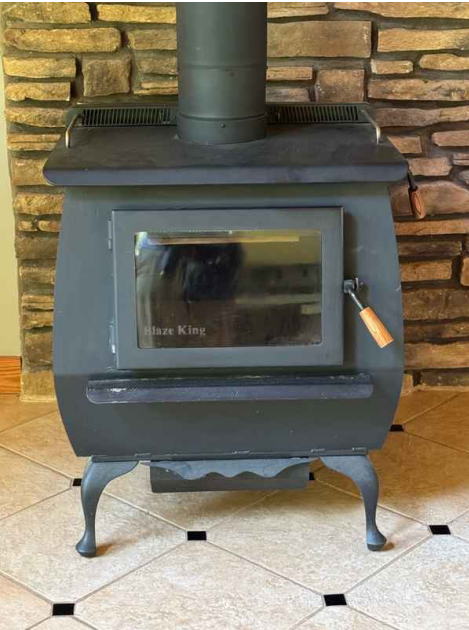
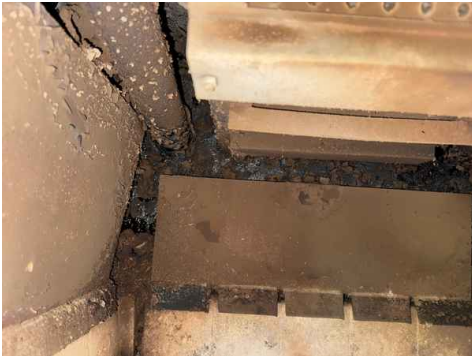
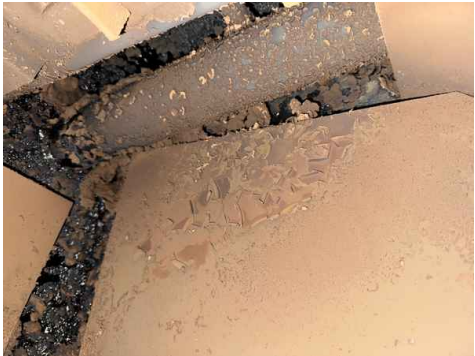
There was a notable amount of creosote buildup in the flue. Recommend a qualified fireplace or chimney contractor inspected and sweep on annual basis.

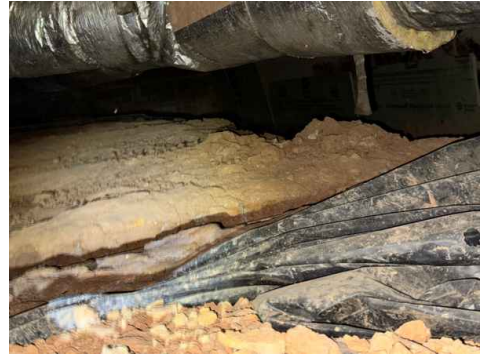
**IMPROPER INSTALLATION**

Vapor barrier is improperly installed. This can result in unwanted moisture. Recommend insulation contractor evaluate.

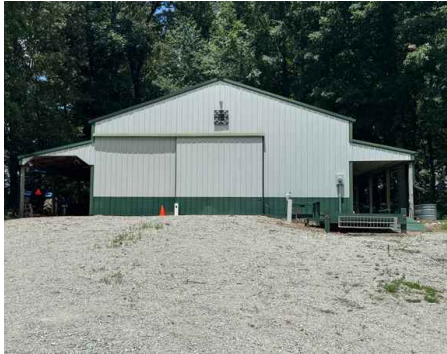
A visual inspection of the exterior resulted in no observed defect to the metal building.

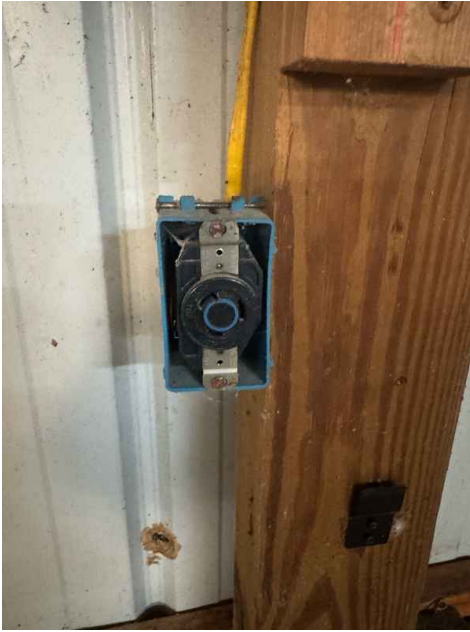
Special 30 AMP plate missing.

Special Outle Damage

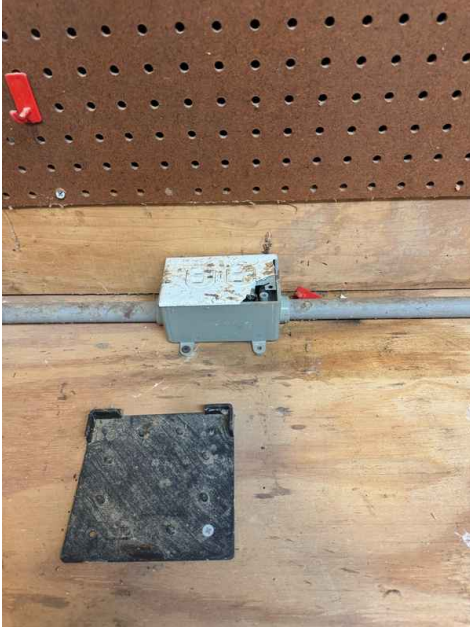
Damaged outlet plate on workbench.

Outlet Cover Damaged

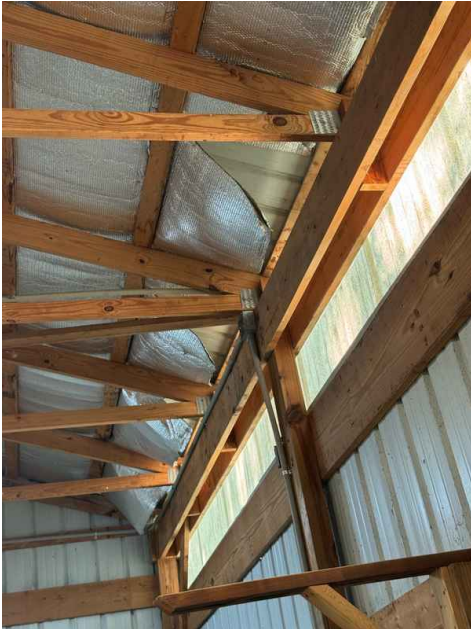
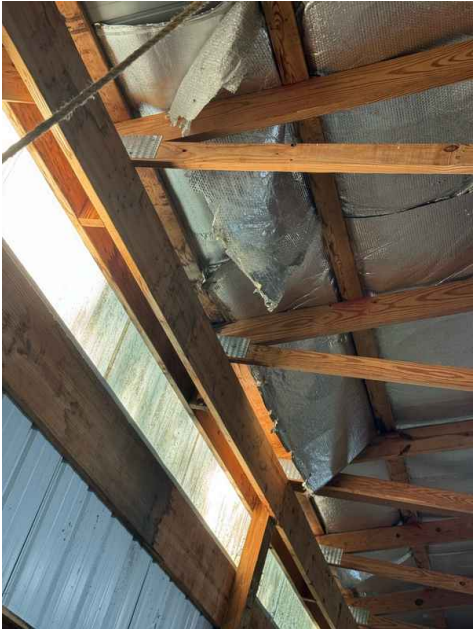
#### 14.1.2 Detached Workshop

Some of the ceiling insulation is coming down from the ceiling. This will result in increased temperatures in the summer and heat loss in winter.

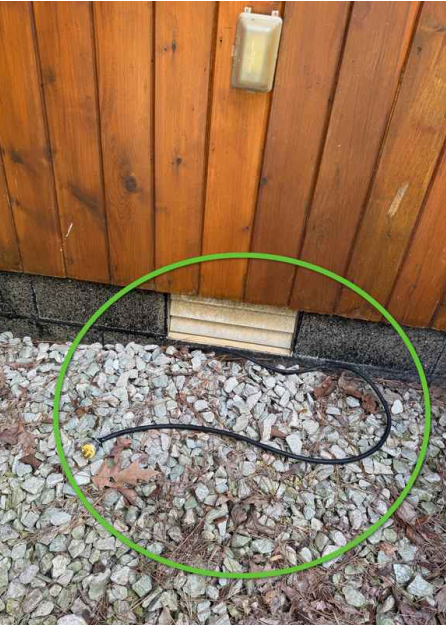
Extention Cord

Eastside Near Front Porch

Visual observation. There is a male end extention cord goind to the ground in the gravel. The owner could not tell me what this was for. There is not power to this cord.

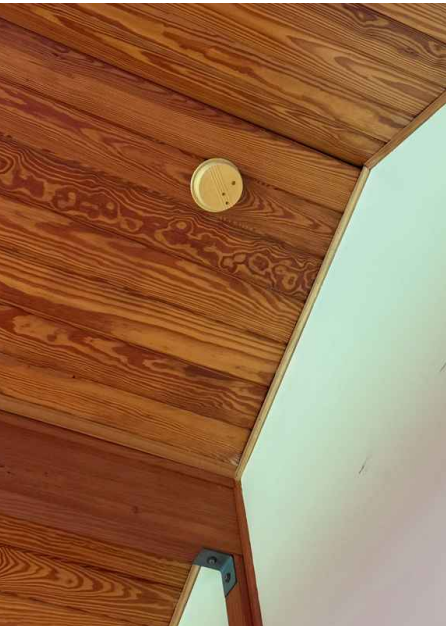
Kitchen-Northside

During the visual observation, a smoke detector in the north kitchen has a smoke detector that is located appox. 16 feet above floor level. Could be a concern when attempting to change the battery or service.
